WA-II-491 Frame House

Maryland Historical Trust State Historic Sites Inventory Form

Survey No.WA-II-491

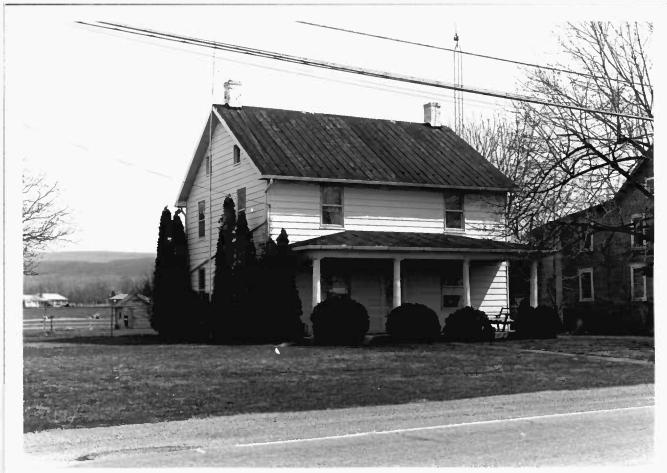
- Frame House WA-II-491
- Washington County, Maryland
- 3. Joe Getty
- 4. May 1983
- 5. Maryland Hist. Trust, Annapolis, Md.
- 6. West & north elevations; camera facing southeast 7. 1/1
